**Golf Hammock Owners' Association**

**Drainage Report**

**Main East Ditch, Lost Ball Drive, Pitching Wedge Way, & Dog Leg Drive**

2925 Kenilworth Blvd.  
Sebring, FL 33870  
(863) 385-5564  
April 5, 2022

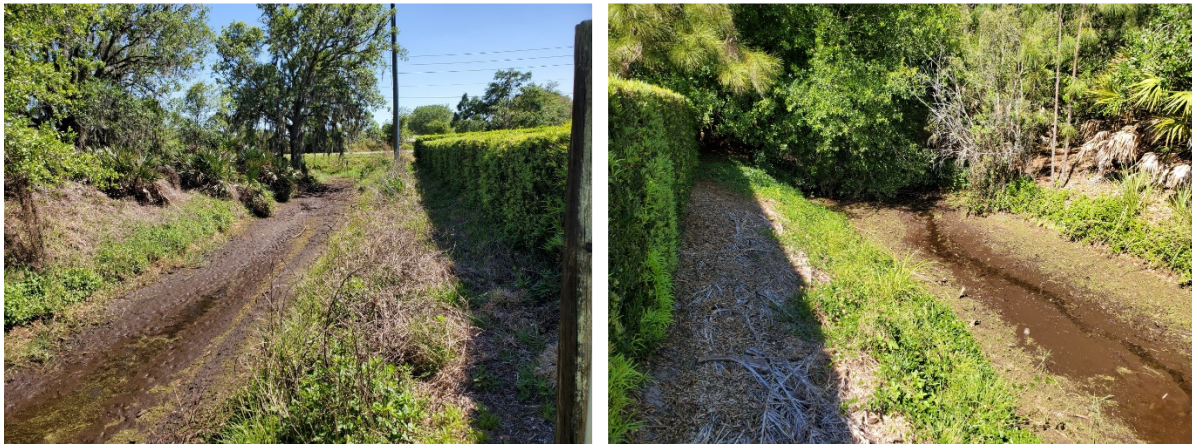
**The two above pictures show the area of the ditch near Hammock Road. The ditch bottom has evidence of silting and its fairly dry compared to other areas of the ditch.**

The recommendations for the main east ditch are for it to be cleaned and the bottom reshaped. No major obstructions were noted during the on-site inspections. It appears the vegetation is overgrown in some areas. The abundance of vegetation contributes to silting in and blockages over time. Leaves and branches fall into the ditch and build up and can bunch together and create blockages in various locations along the ditch path. One notable location is the water main crossing. It is possible this area can get blocked during heavy rain events if any debris get washed against the pipe. The information about the blockages was also mentioned by resident John McAngus at 3415 Par Road.

Methods of cleaning the ditch would be removal of the silts at the bottom of the ditch and mechanical removal of overhanging vegetation. This would include saw cutting and trimming of the vegetation. Root ball removal, especially in the banks of the ditch, would not be recommended. This vegetation also stabilizes the slopes of the ditch. Exact methods of this work will need the input of the contractor that will be hired for the work. The majority of the ditch is also appears to be located within the rear easements of the lots along Sebring Hills. Cooperation with the Sebring Hills HOA may need to be coordinated at the time of any maintenance.

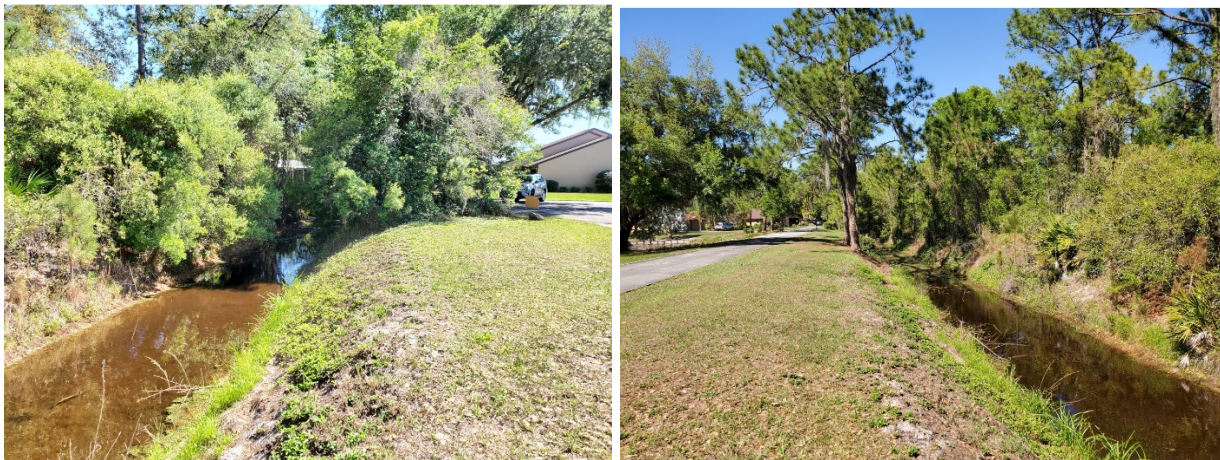
**These two pictures show the area close to the cul-de-sac of Cormorant Point Drive. The slopes are fairly clean of overgrowth, but the bottoms are wet and have some signs of silt build up.**

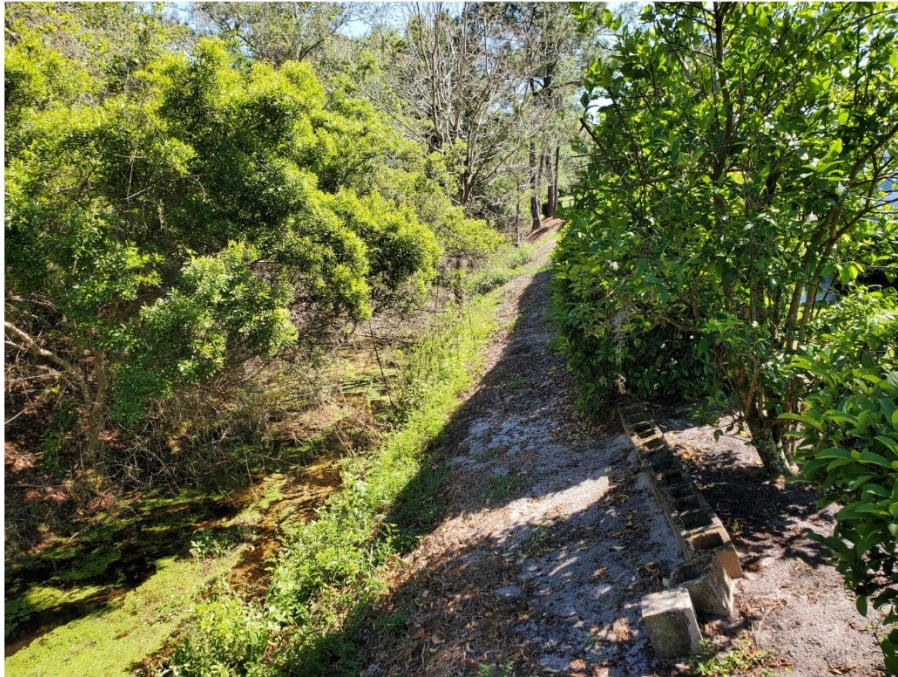
**This picture depicts the area of the ditch near Fairway Road. Vegetation is more prevalent on the Sebring Hills side of the ditch than the Golf Hammock side. The bottom has signs of silting in.**

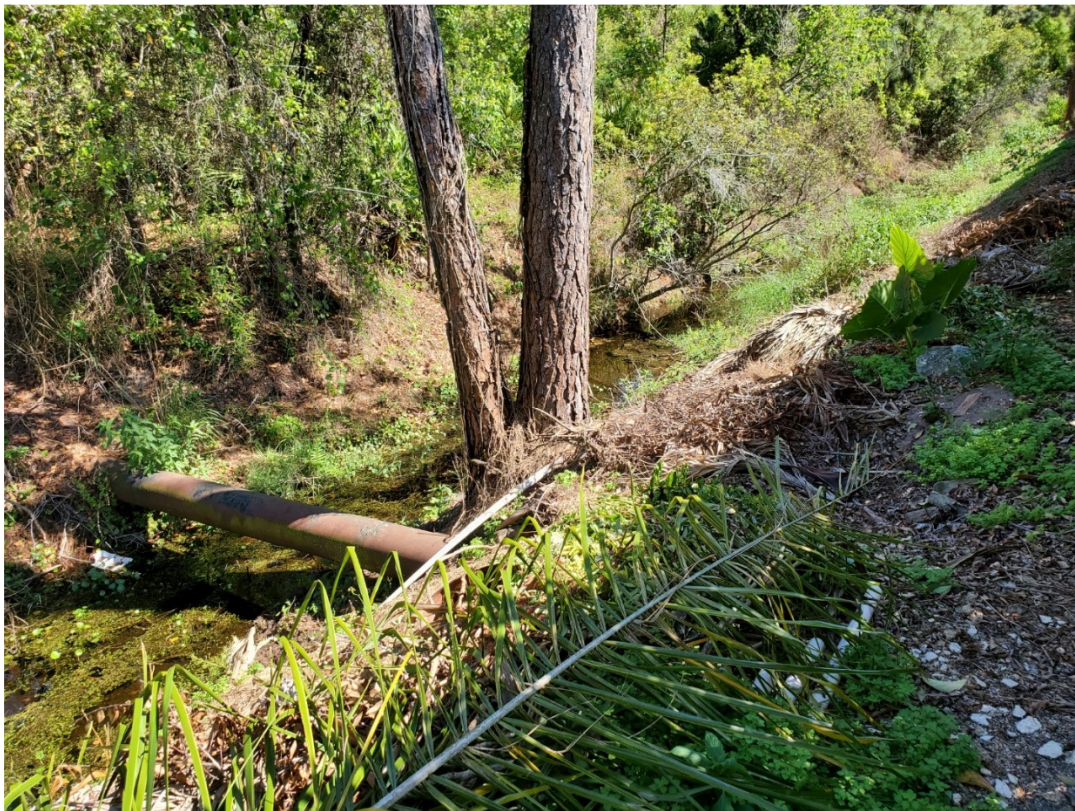
**This picture depicts the City water main crossing of the ditch.**

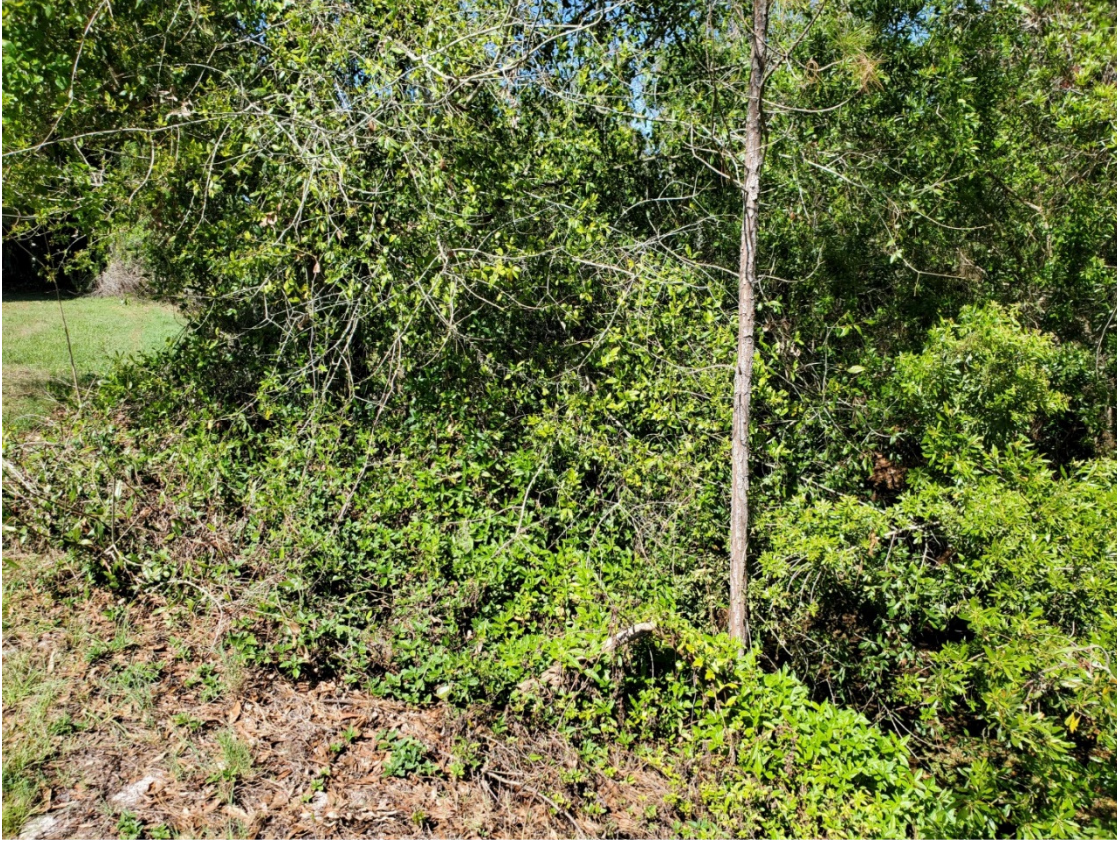
**Complete vegetation overgrowth of the ditch area.**

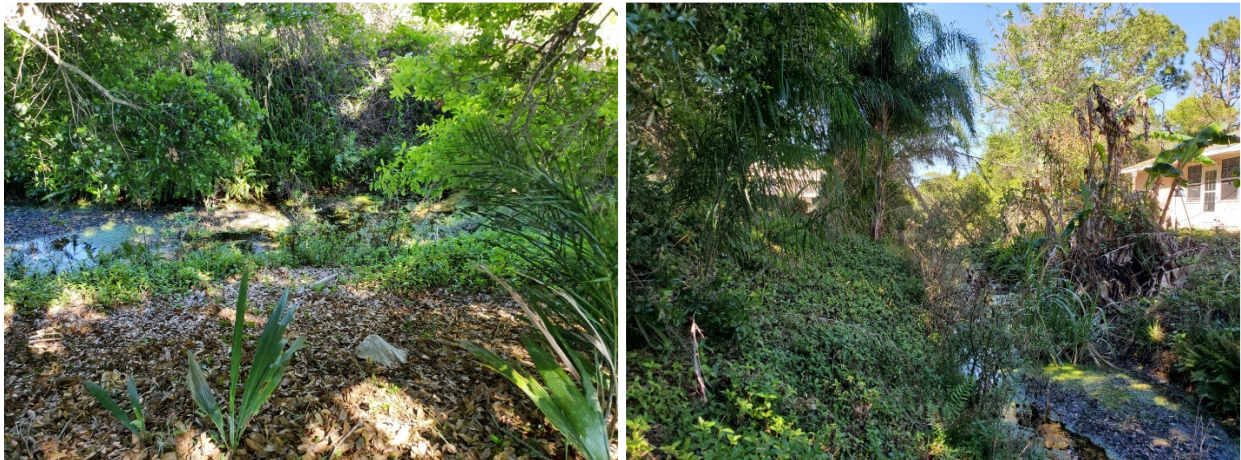
**Moderate overgrowth of the ditch area as well as silting and build up in the ditch bottom.**

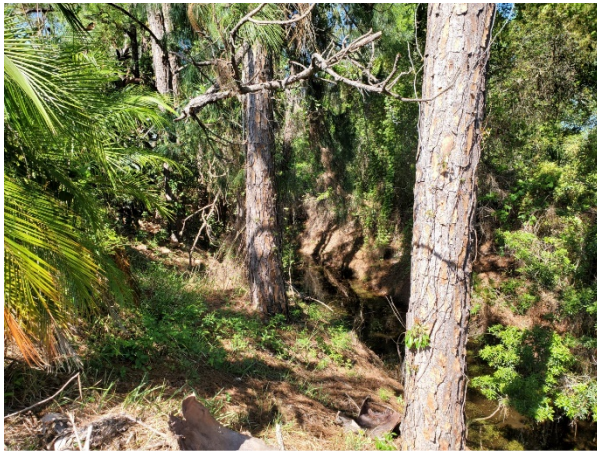
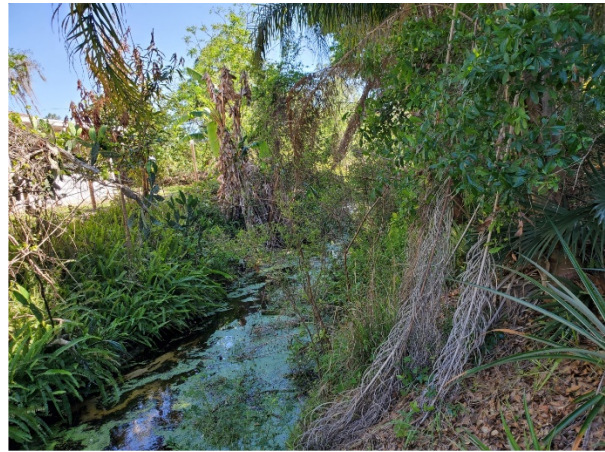
**The above pictures depict overgrowth of vegetation on the banks.**

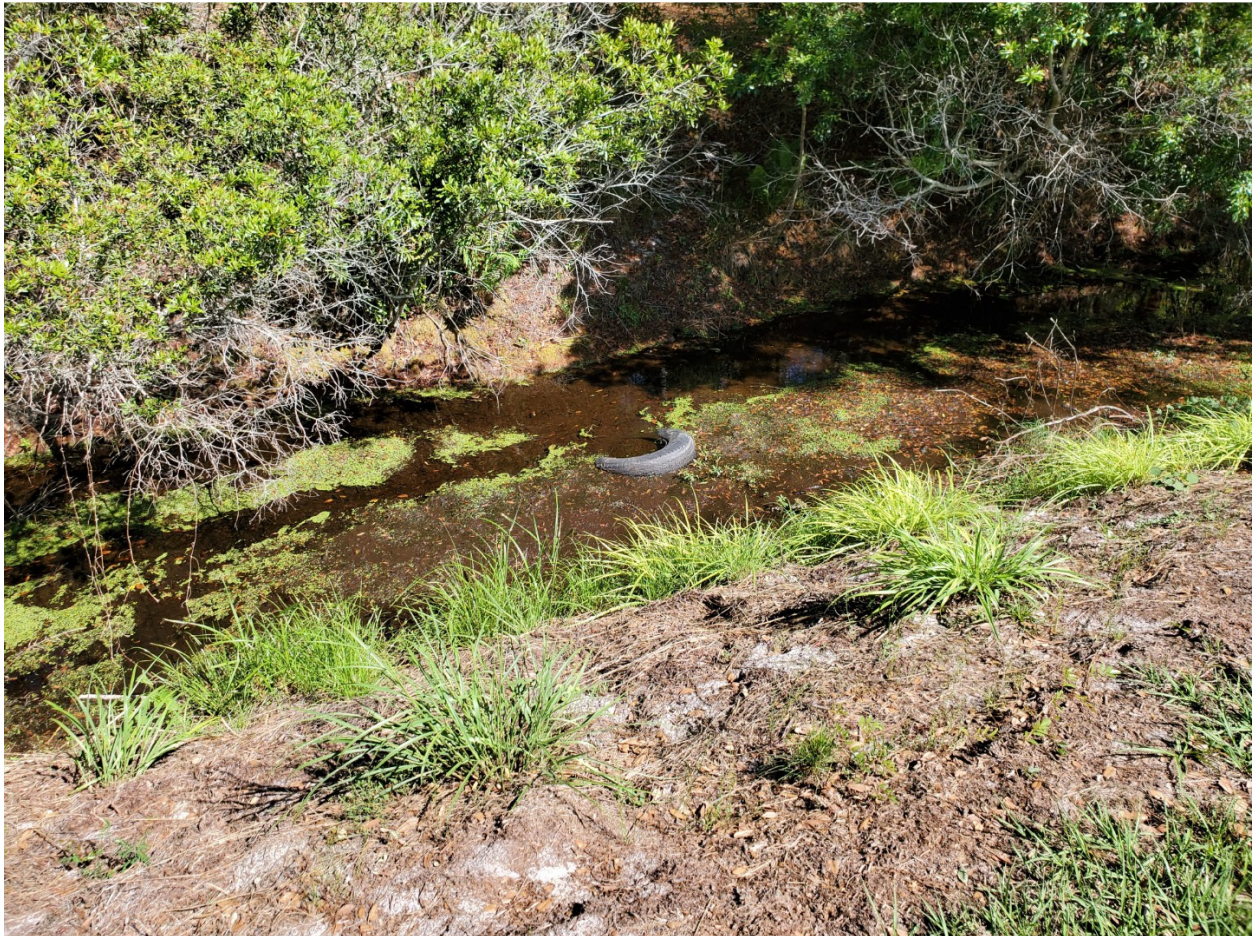
**A tire is in the bottom of the ditch in the picture above. This was not the only instance a tire was seen in the ditch bottom.**

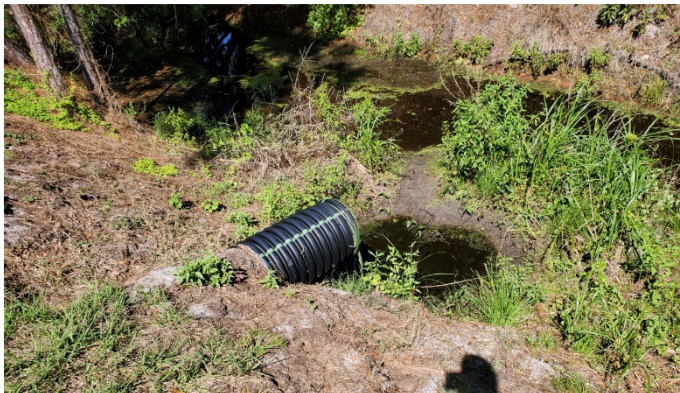
No major blockages were noted at the time of the on-site inspection. Some erosion was noted near the outfall pipe north of the cul-de-sac of Cormorant Point Drive. It would be recommended

to have the slope restored and rip-rap installed in this area to prevent further erosion. It would be beneficial to plan for ditch cleaning maintenance work, but it does not appear to be an emergency to have done immediately.

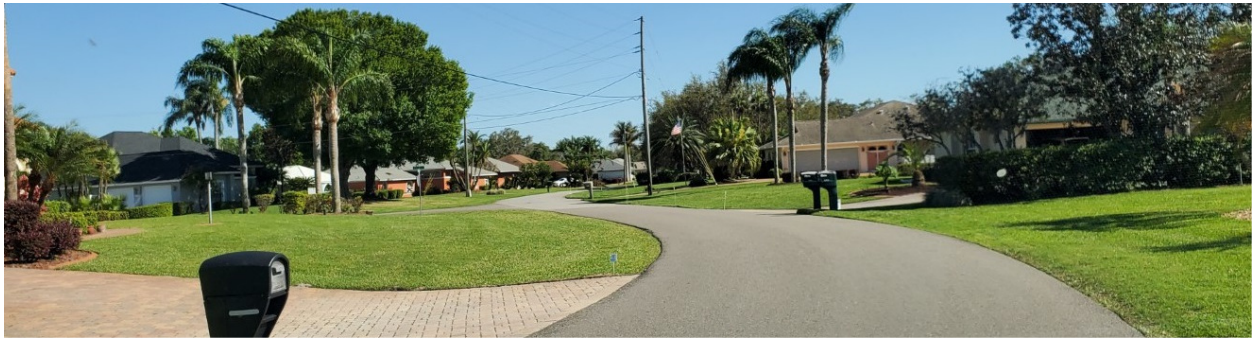
**This is the view south along Lost Ball Drive. Main area of concern is on the right of the road. The ditches appear to be fairly shallow and may have some undulations.**

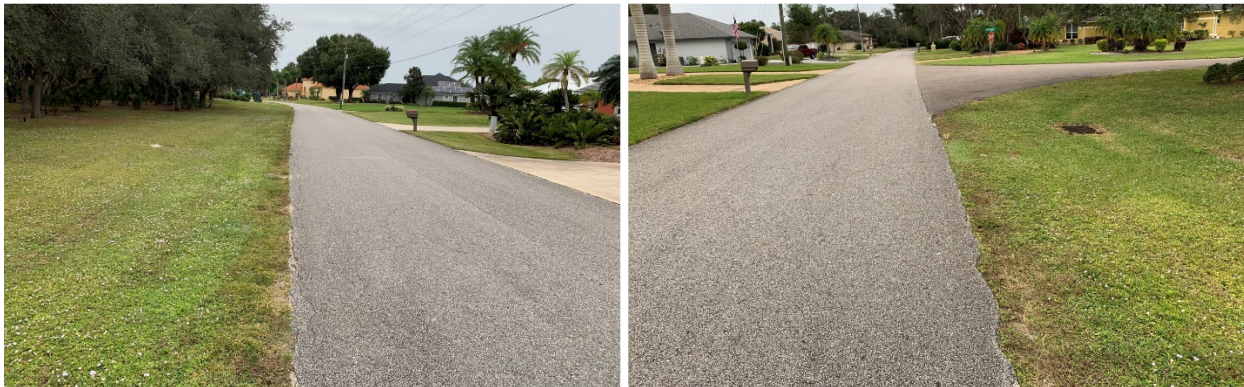
**The picture to the left depicts the road view north along Lost Ball, just north of Lost Ball Ct. The picture to the right depicts the view south in the same area. It also depicts the potential tie-in inlet for the sock pipe option.**

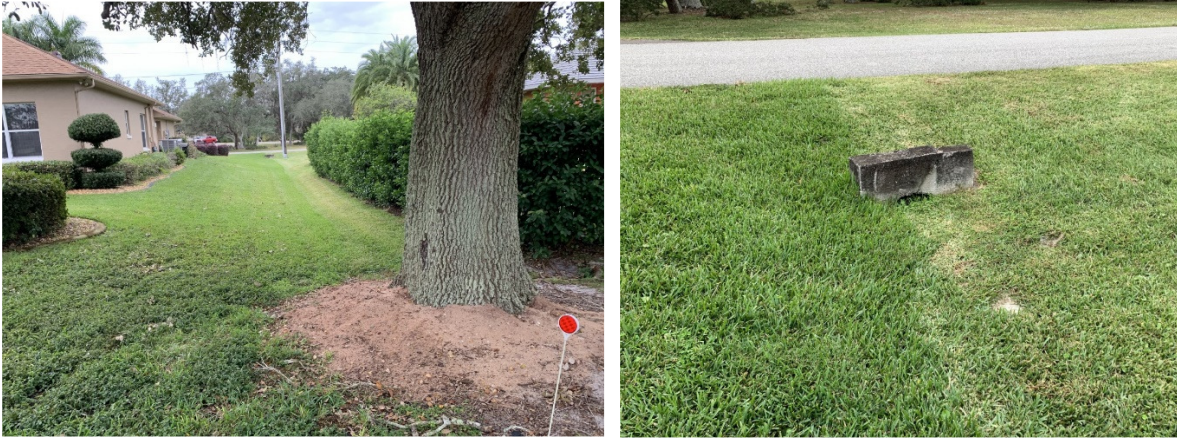
The next hurdle in this area is the existing inlet and culvert crossing. This was mentioned in the previous report. The inlet and culvert appear to be in working order, except needing minor maintenance, the issue was it had no visible outfall. The culvert dumps the water into a side lot ditch and ends with a large oak tree. We may be able to get the water to move from the road side ditch and into that inlet, but we may create a problem down stream if we do not address it as well.

**Pictures of Culvert Crossing and Side Ditch from Previous Report**

Work in this area is not recommended without fully addressing the down stream issues. Sending more water to an area without an outfall will likely create more problems.

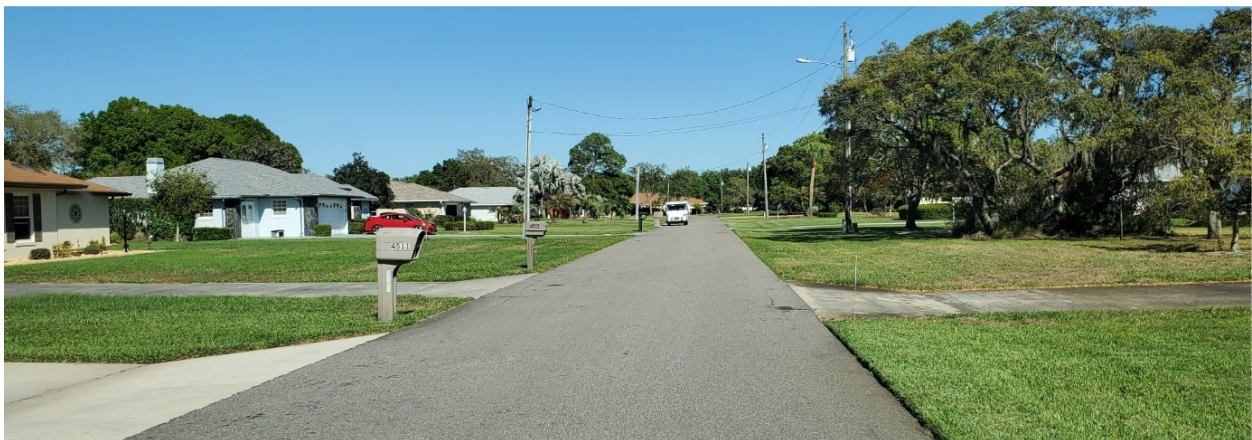
**The above image depicts the ditches and driveway dips along Pitching Wedge Way. The ditch areas are fairly shallow, and the driveway dips vary in depth. Both of these items can promote ponding in the ditch areas.**

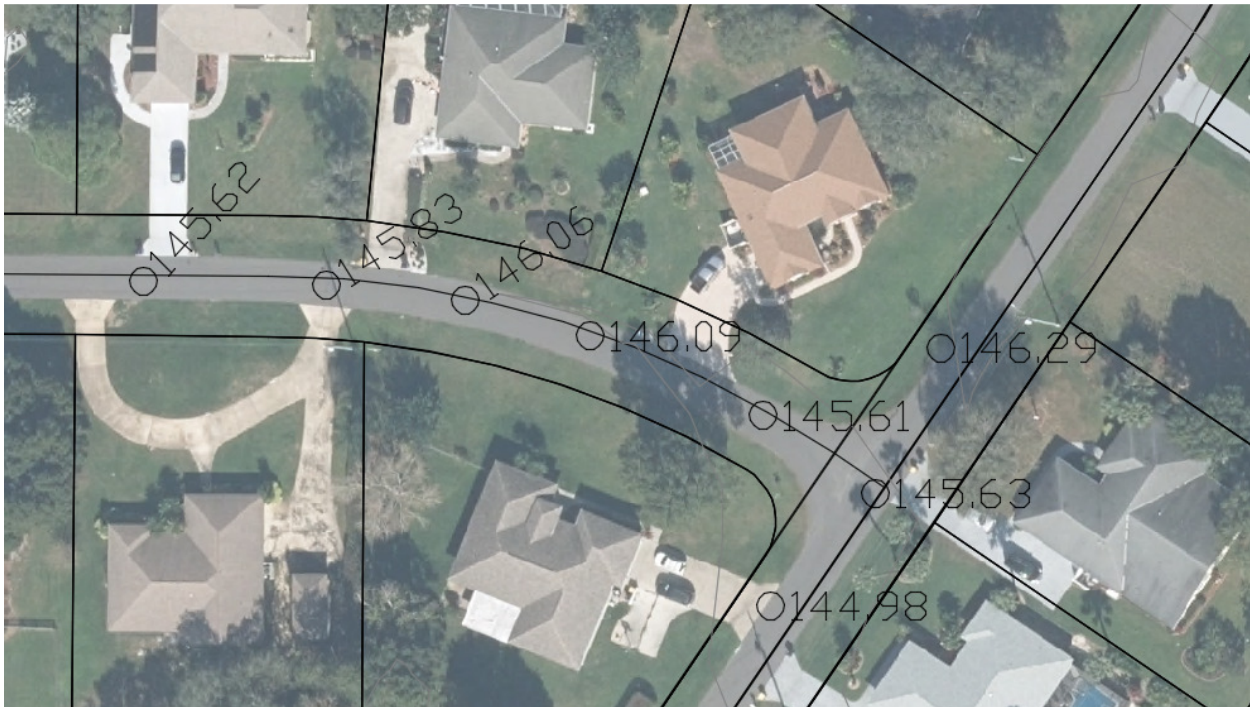
**The above image depicts point elevations provided by LIDAR from SWFWMD. The rise is approximately 6 inches along the first lot on Pitching Wedge Way. This is likely the cause of the standing water at the intersection ditch to the north.**

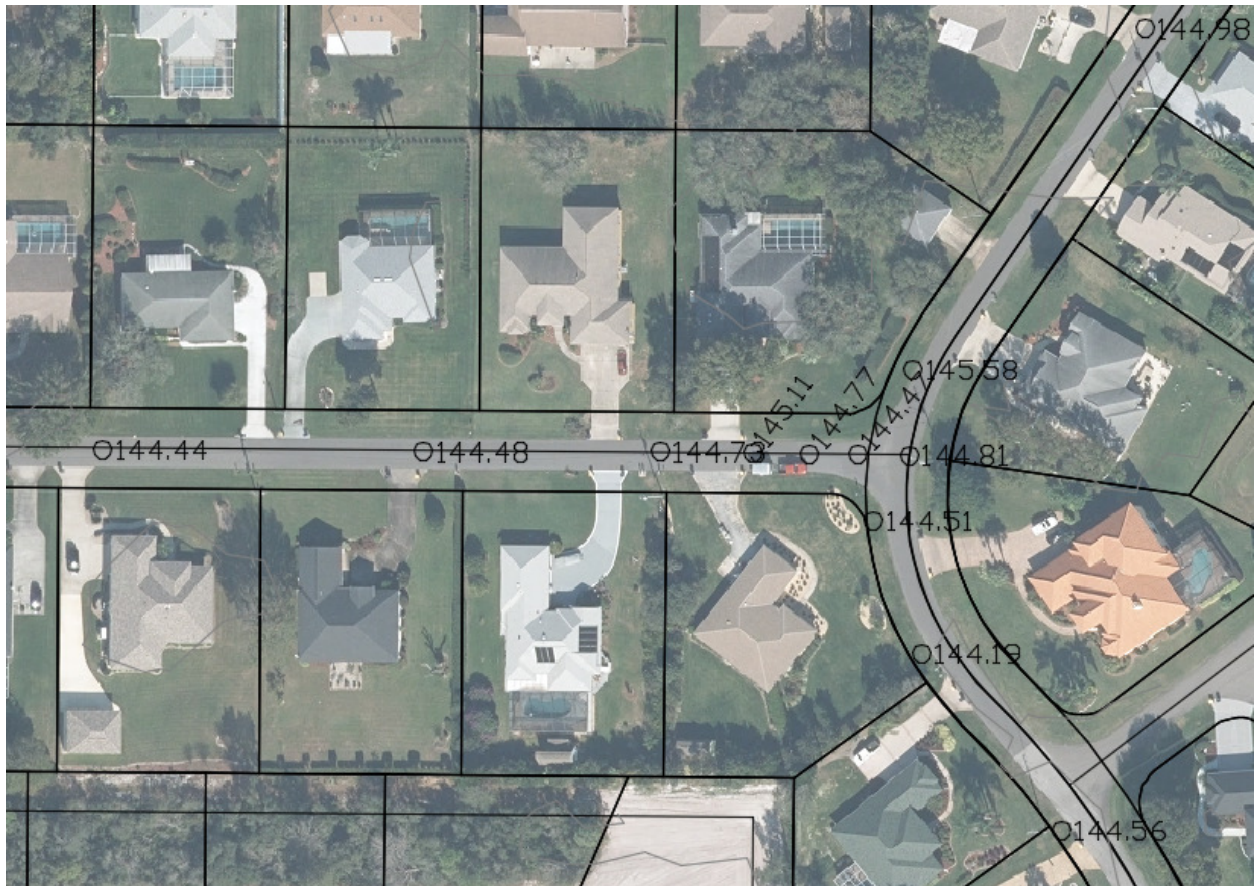
**The above image depicts point elevations provided by LIDAR from SWFWMD. The rise is approximately 7 inches along the first lot on Dog Leg Drive. This is likely the cause of the standing water at the intersection ditch to the north.**

The recommendations for the areas of Dog Leg Drive and Pitching Wedge Way, listed in this report, are mostly complaint driven responses. Assuming the described water ponding is reoccurring each rain season, it may require sock pipe to convey the water away from the low spots along the ditch. If the ponding only last 24 to 48 hours it could be considered nuisance water and not an emergency to address. That being said, it still may be in the best interest of Golf Hammock to address the standing water to help reduce mosquito breeding areas and to keep grass from dying each season in the right of way.

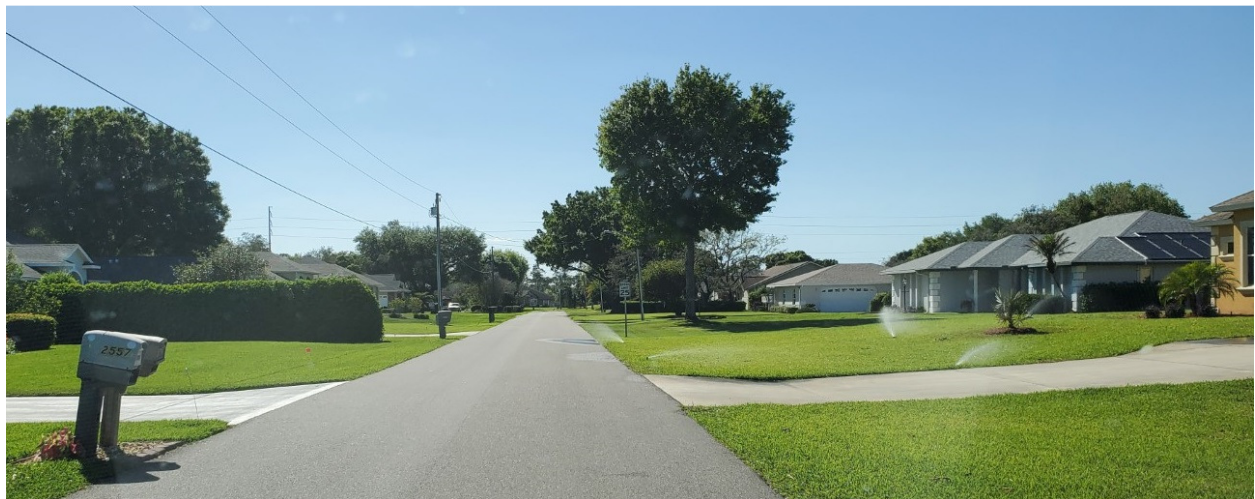
**The above image depicts the ditches and driveway dips along Pitching Dog Leg Drive. The ditch areas vary from shallow to somewhat flat, and the driveway dips vary in depth. Both of these items can promote ponding in the ditch areas.**
