**Golf Hammock Owners' Association**

**Drainage Report**

**Main East Ditch, Lost Ball Drive, Pitching Wedge Way, & Dog Leg Drive**

2925 Kenilworth Blvd.  
Sebring, FL 33870  
(863) 385-5564  
April 5, 2022

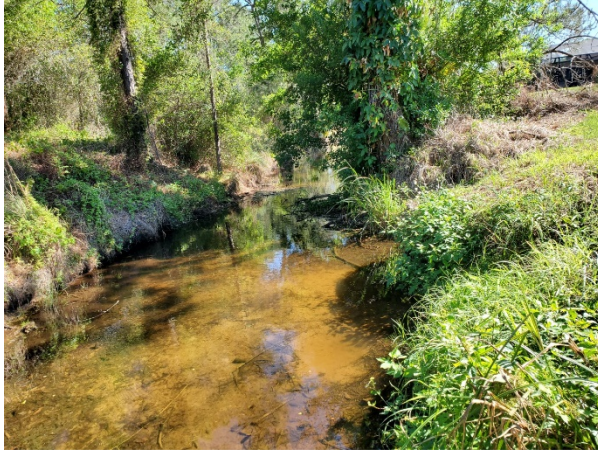
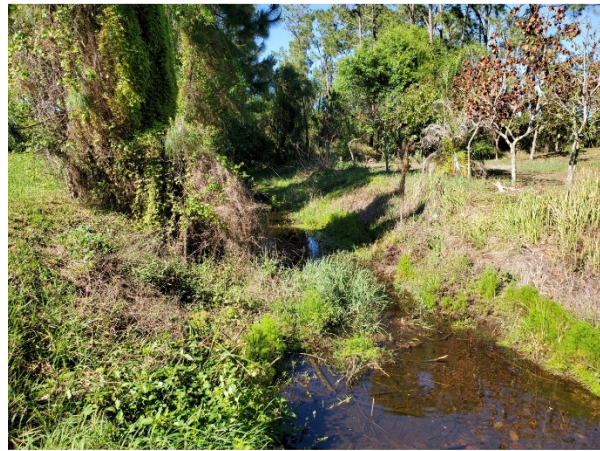
**These pictures of the ditch were approaching the northerly end of the ditch.**

The recommendations for the main east ditch are for it to be cleaned and the bottom reshaped. No major obstructions were noted during the on-site inspections. It appears the vegetation is overgrown in some areas. The abundance of vegetation contributes to silting in and blockages over time. Leaves and branches fall into the ditch and build up and can bunch together and create blockages in various locations along the ditch path. One notable location is the water main crossing. It is possible this area can get blocked during heavy rain events if any debris get washed against the pipe. The information about the blockages was also mentioned by resident John McAngus at 3415 Par Road.

Methods of cleaning the ditch would be removal of the silts at the bottom of the ditch and mechanical removal of overhanging vegetation. This would include saw cutting and trimming of the vegetation. Root ball removal, especially in the banks of the ditch, would not be recommended. This vegetation also stabilizes the slopes of the ditch. Exact methods of this work will need the input of the contractor that will be hired for the work. The majority of the ditch is also appears to be located within the rear easements of the lots along Sebring Hills. Cooperation with the Sebring Hills HOA may need to be coordinated at the time of any maintenance.

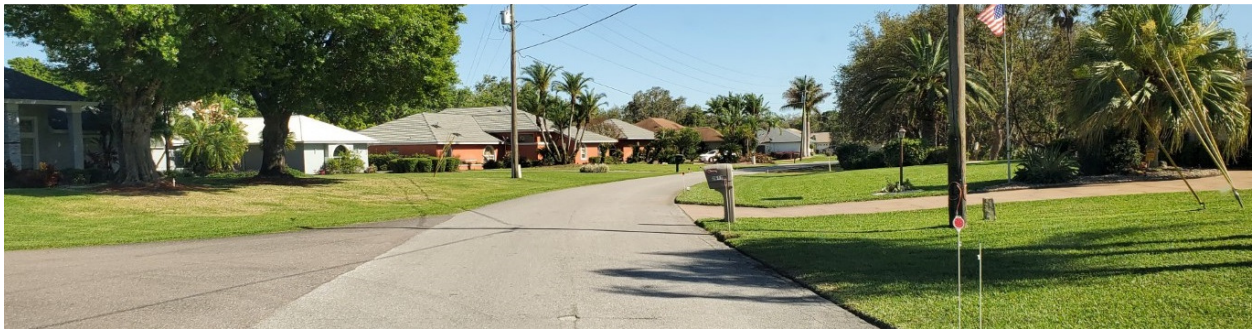
**This is the view south along Lost Ball Drive. Main area of concern is on the right of the road. The ditches appear to be fairly shallow and may have some undulations.**

**Another view south**

Work in this area is not recommended without fully addressing the down stream issues. Sending more water to an area without an outfall will likely create more problems.
